ELECTRICAL FEEDER SYSTEM

Utilities Backed by CFES

Leaks and Regulatory Pressures on the System

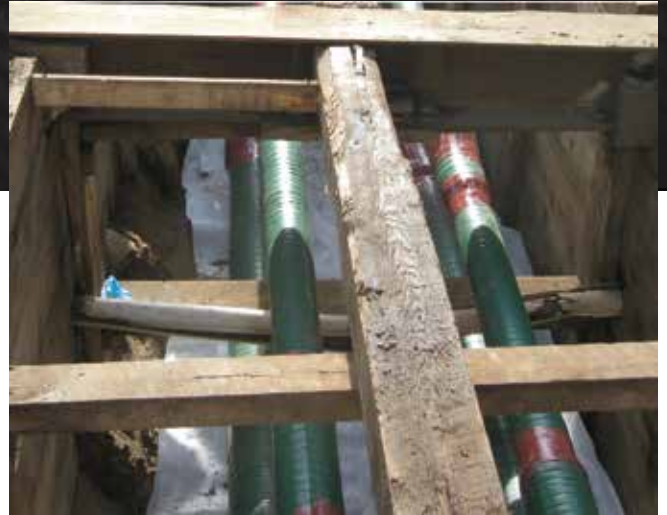
A major northeastern utility was experiencing an unacceptable amount of dielectric fluid leaks on its underground 345kV electrical feeder system. System reliability was being impacted and the state's environmental protection agency was threatening to impose an administrative consent order forcing them to replace the aging lines.

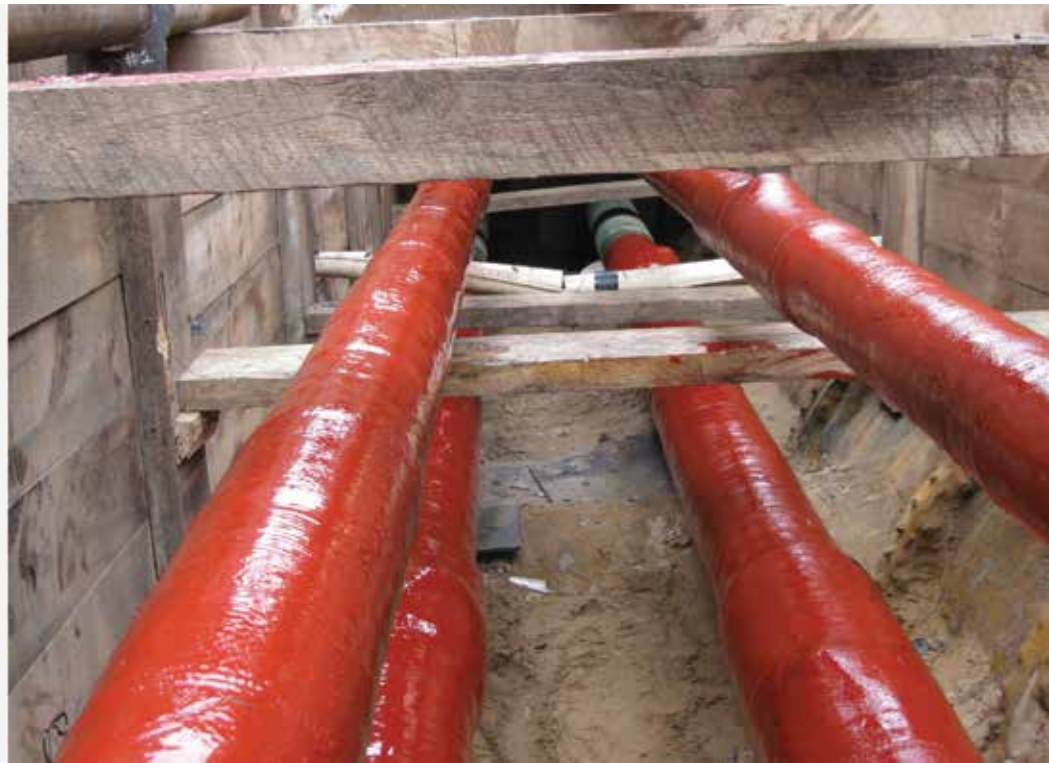
Since the system provided power to millions of people, it could not be taken out of service. The repair solution needed to be meticulously designed with a high certainty of the outcome. Other factors impacting the repair were temporary barrel repairs and clamps that were installed through the system and the system was coated with an asbestos-containing mastic. The repair would need to be installed around these constraints while maintaining the integrity of the system.

Carbon Fiber Engineered Solutions installed our engineered system while the electrical feeders remained fully energized. The solution fully encapsulated the existing electrical feeders, previous barrel repairs, and asbestos-containing mastic coating. The composite carbon fiber solution is rated for 1,000 psi and serves as a secondary pressure boundary for the existing feeders.

As a result, the leaks were stopped, cleanup efforts and environmental reporting were eliminated, system reliability was restored, and the system was extended with **over 30 years** of maintenance-free life.
